**NBSIR 73-148**

# **Evaluation of the Column Connections Used in a Precast Concrete Modular Housing System**

**Felix Y. Yokel and Thomas W. Reichard**

**March 26, 1973**

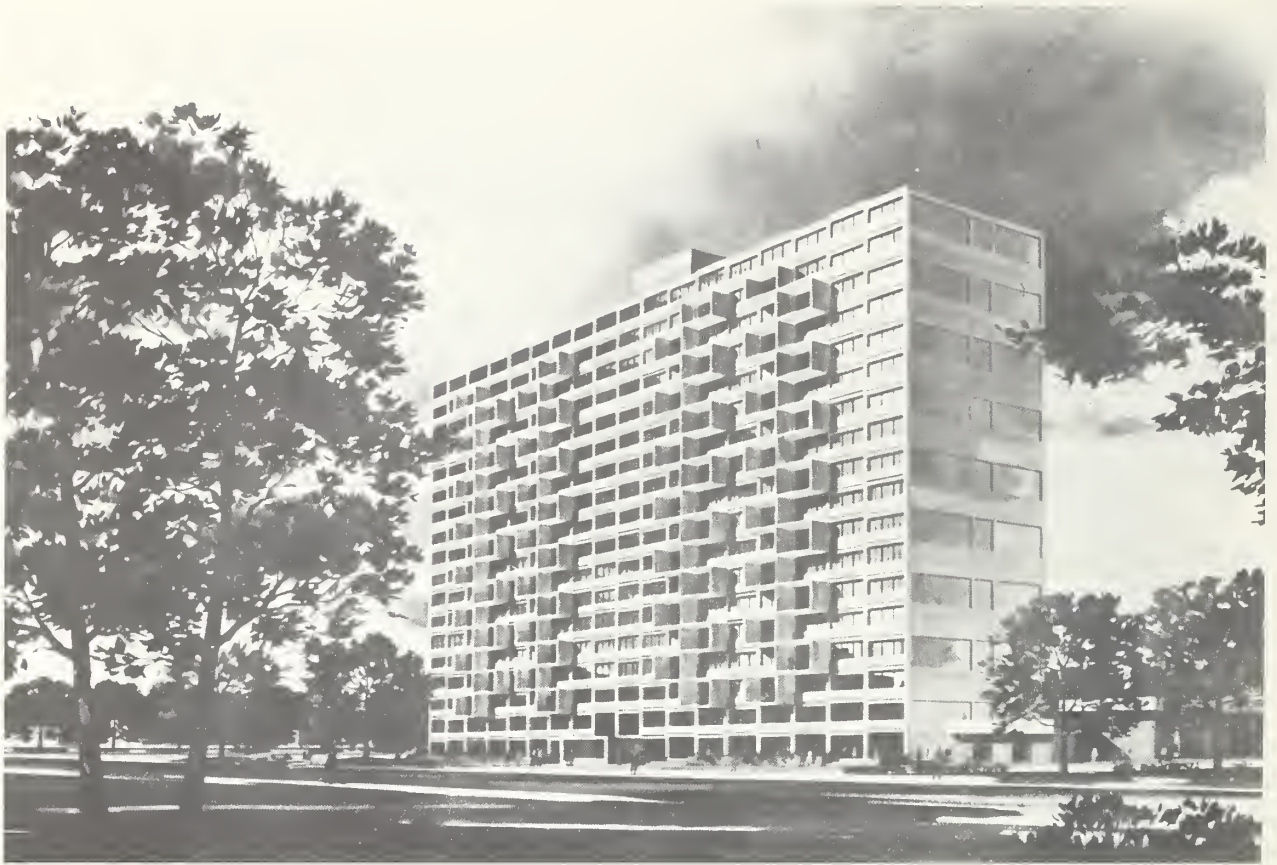
FIGURE 2.1 PROPOSED BUILDING

The proposed system consisted of precast reinforced light-weight concrete box modules, stacked in a checkerboard pattern. Figure 2.1 shows one of the buildings proposed for construction, a 19-story structure. Figure 2.2 shows the model of a complex of buildings which is under construction using the structural concepts and connection details evaluated in this report, however, the modules differ in size and configuration from those proposed for the structure shown in figure 2.1.

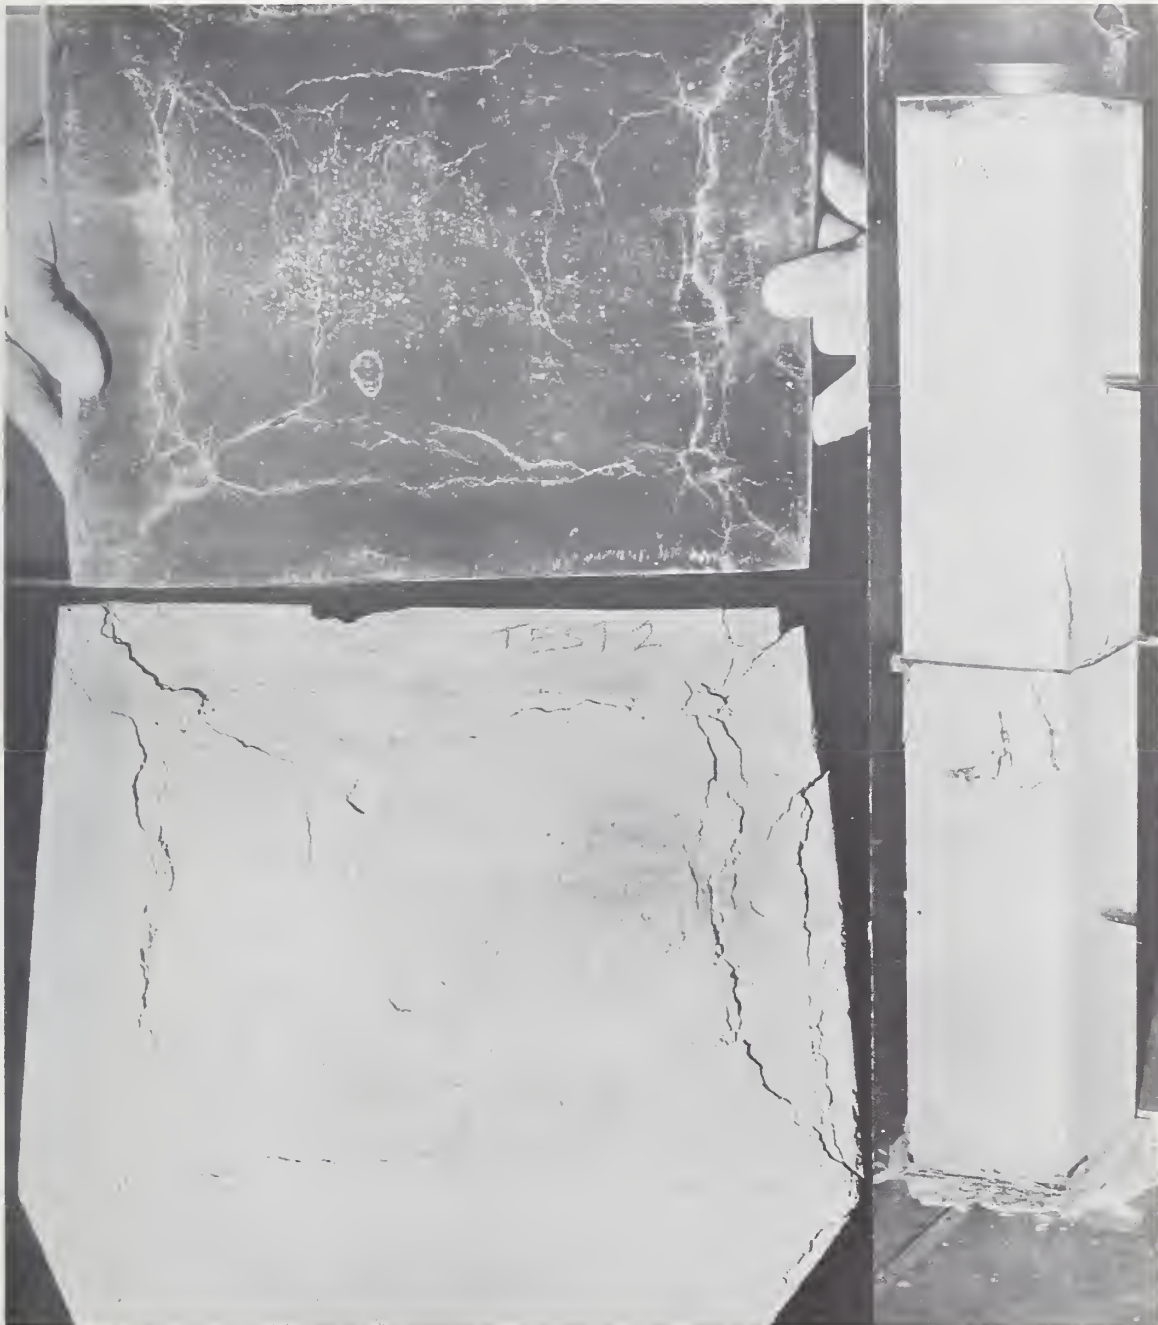
FIGURE 4.5 TYPICAL FAILURE OF CONNECTION USING 1/4-IN NEOPRENE PAD

Figure 4.5 shows a typical failure of a connection using a neoprene pad. The spalling between the core inside the ties and the shell outside the ties is an indication that at ultimate load the core supported most of the load. The same observation can be made in figure 4.6 which shows the typical failure of a grouted connection.

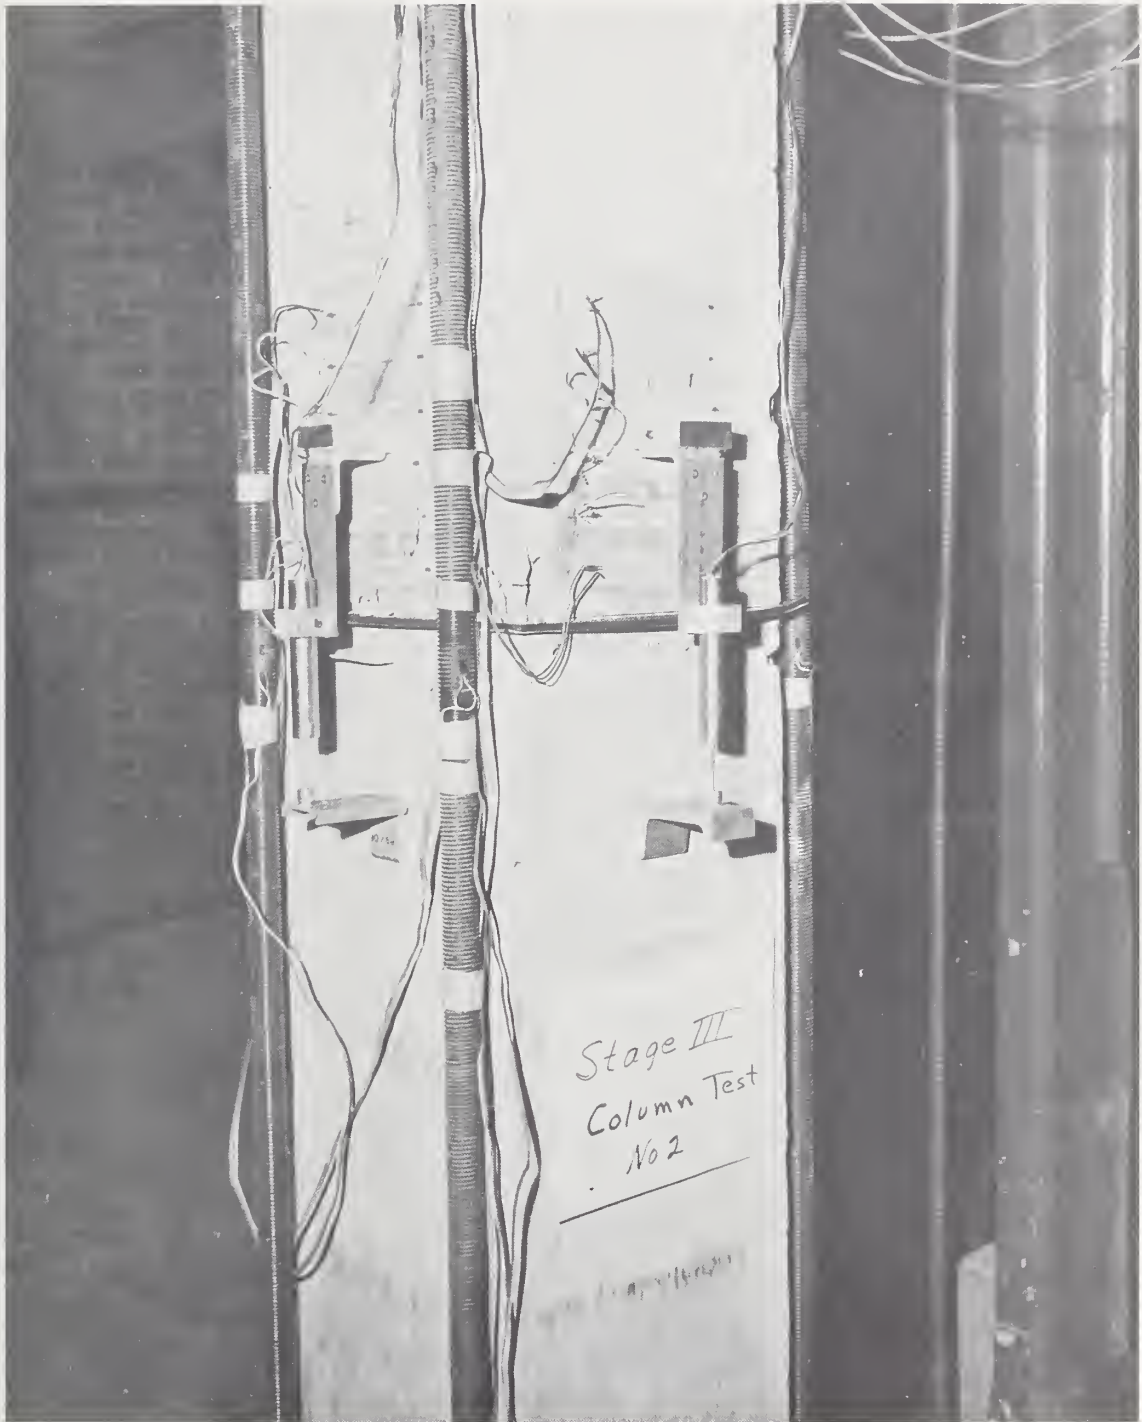
FIGURE 4.15 INSTRUMENTATION OF TEST SPECIMEN WITH GROUTED DOWEL

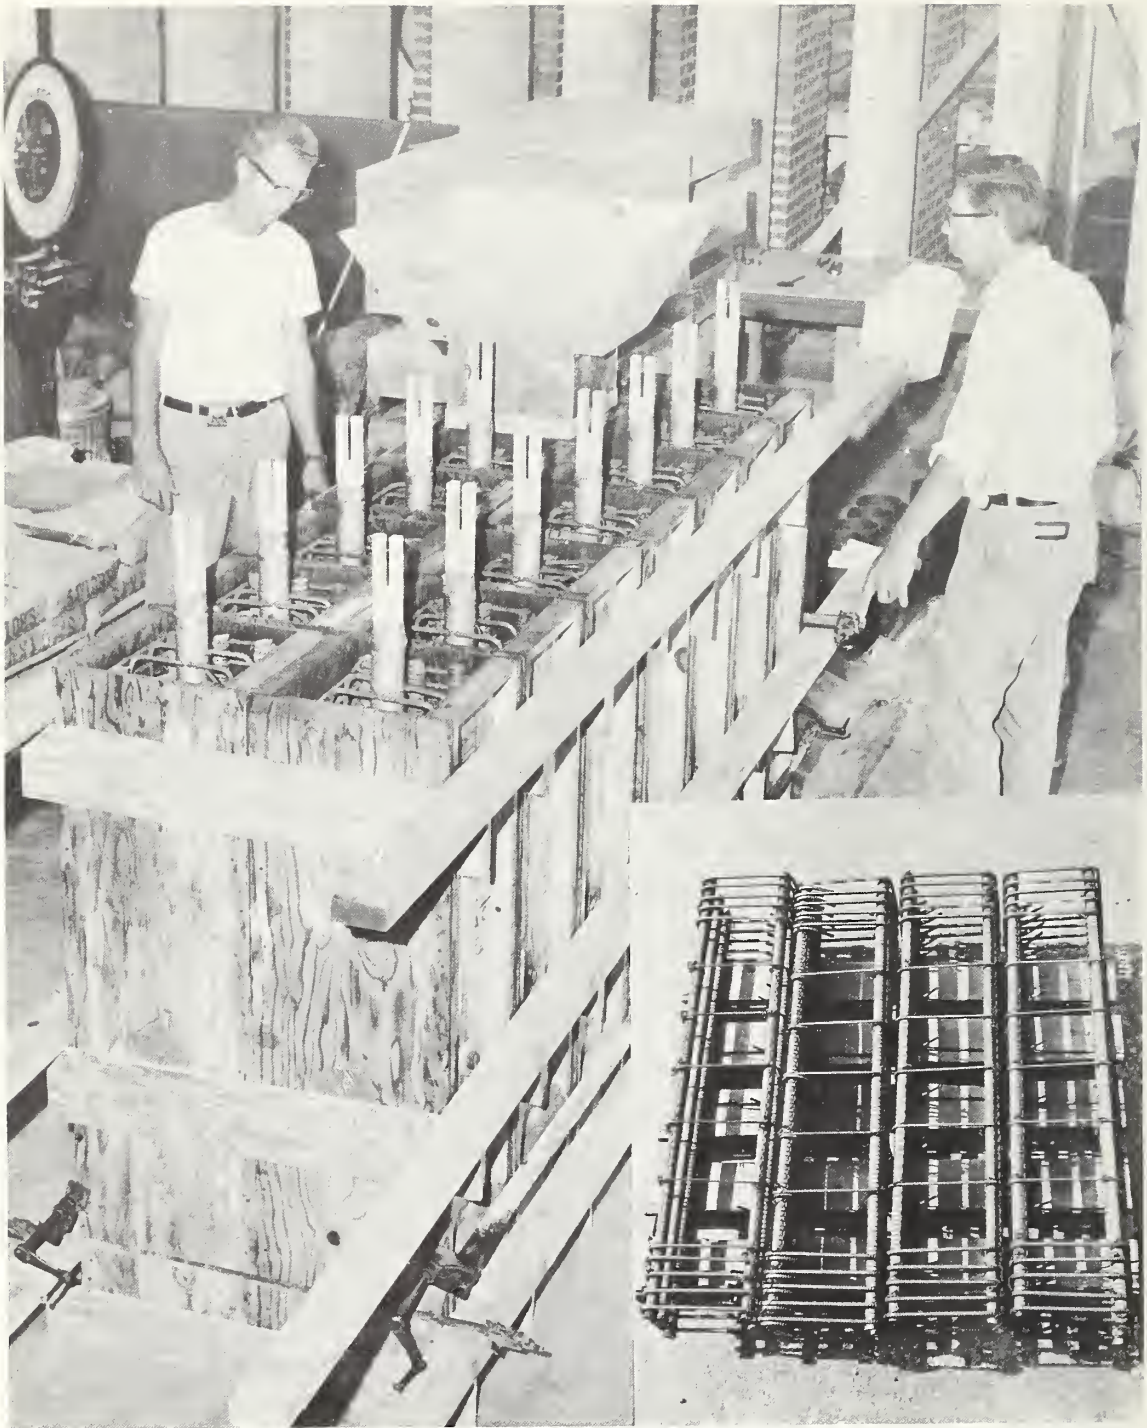
FIGURE 4.20 DETAILS OF SHEAR TEST SPECIMENS
